# Rust Coloured Stains on the surface of Exposed Aggregate Concrete

## What is causing the Rust Coloured Stains

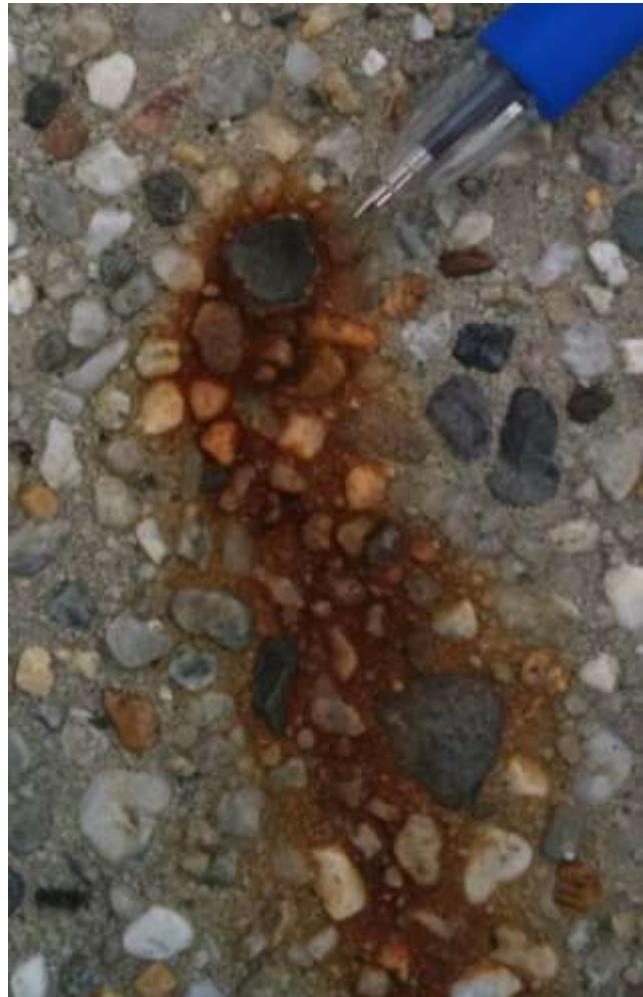
This document deals specifically with rust coloured stains created by “Ironstone” on the surface of Exposed Aggregate Concrete.

Ironstone is the common term used to describe unstable aggregate (stone) particles that are rich in iron oxide minerals. These stones are generally dark grey to black in appearance (once oxidation has commenced) and are more commonly found in river pebbles. It is believed that these minerals are a form of iron pyrite (related to fools gold) that begins to rapidly oxidise on exposure to air and moisture.

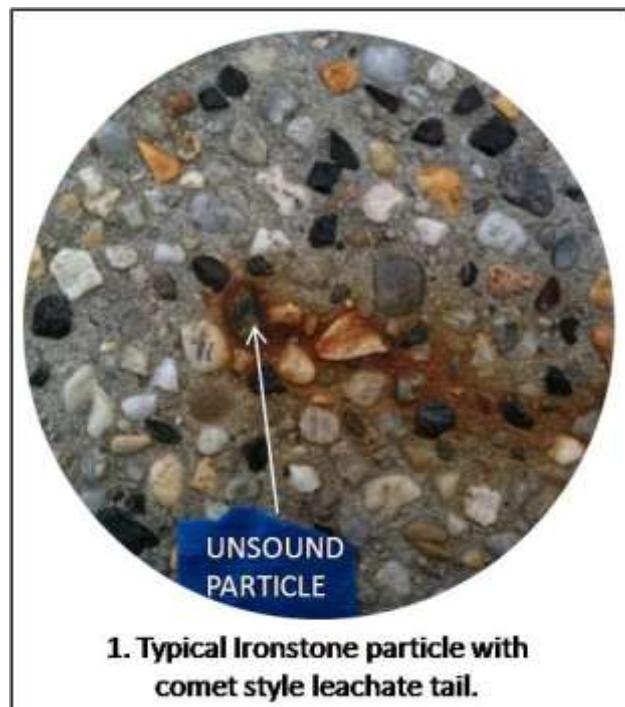
A typical incidence of Ironstone after commencement of oxidisation is typified by:

- a. A fractured remain of dark grey to black 3 to 14 mm size aggregate particle at the centre of a small, shallow, micro crater type hole on the surface where the stain has maximum intensity and the unsound particle has erupted and is in the process of disintegration.
- b. A dark reddish brown stain on an otherwise sound concrete surface.

It is quite possible to just remove the rust coloured stains with a dilute solution of iron-stain remover (or an acid, although it's not as controllable as the proprietary solutions). But to prevent the staining from reoccurring you have to remove the offending aggregate particle first.

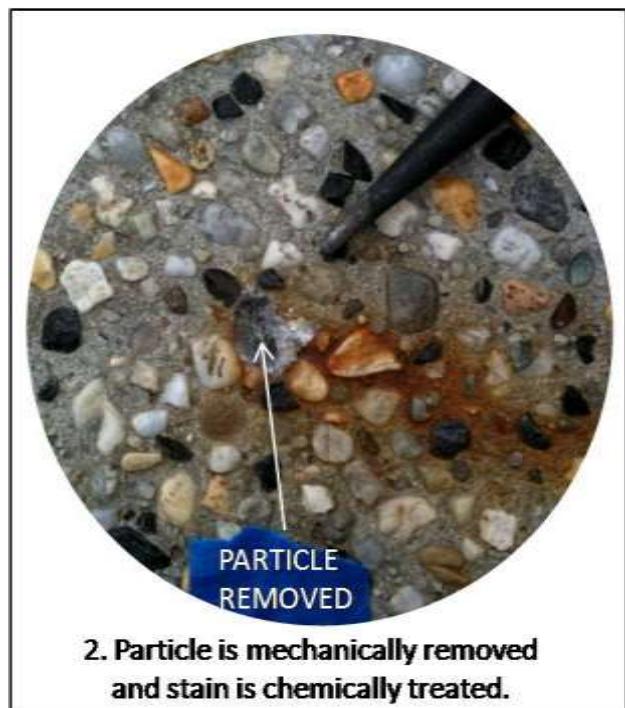
**2. Particle is mechanically removed and stain is chemically treated.**

- a. Drilling the particle out of the concrete using a masonry bit; or
- b. Breaking the particle out of the concrete with a hard pointed implement – a nail hole punch and hammer works well for this.

With some time and practice, you should be able to quickly punch out the dark ironstone leaving behind a small crater as can be seen in the photograph above.

Once you have established confidence in a cleaning solution that will remove the rust stain without any significant side effects, treat each marked area systematically so as not to miss any. Pay attention to the time you leave your cleaning solution on there, and make sure it does not dry out in the meantime.

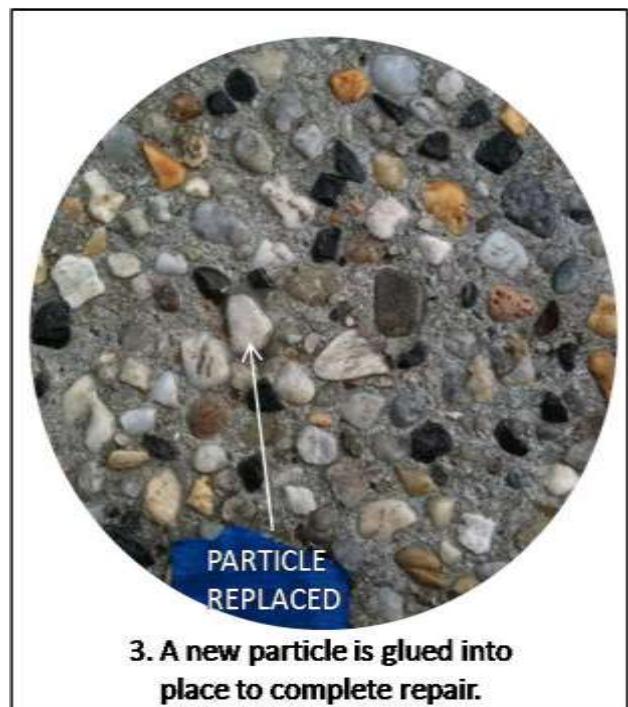
**3. A new particle is glued into place to complete repair.**

The final step in repair is to assess the size of each crater and glue a new sound stone particle into it. In some cases, the crater is so small that no further action is needed to enable it to blend with its surroundings.

Clear or opaque epoxy glue is recommended for adhesion of new stone particles into the crater left behind from removal of the ironstone.
