# Rust Coloured Stains on the surface of Exposed Aggregate Concrete

## What is causing the Rust Coloured Stains

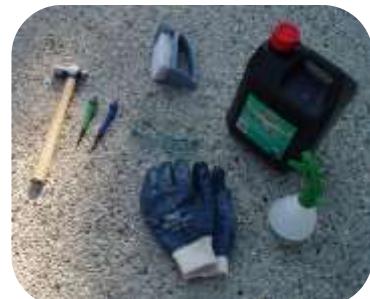
It is quite possible to just remove the rust coloured stains with a dilute solution of iron-stain remover (or an acid, although it's not as controllable as the proprietary solutions). But to prevent the staining from reoccurring you have to remove the offending aggregate particle first.

What follows is a detailed procedure for identification, temporary marking, removal of unsound particles, chemical treatment of stains, and fixing of new particles into place.
